Manhole Inspection Summary

Manhole # S31GG_042MH

Insp Date: 1/19/07 11:04 AM

Location Address: **1203 JOHN ST**

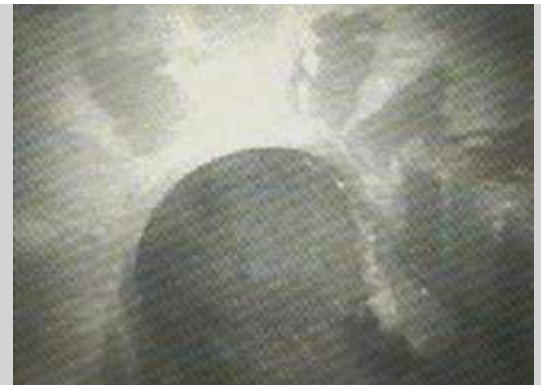
Drop In @ 4 O'Clock

Infiltration: **Evidence** Pipe Seal Cond: **Unknown**

Drop: **Outside** Rod and Bar

Drop Condition: **Open**

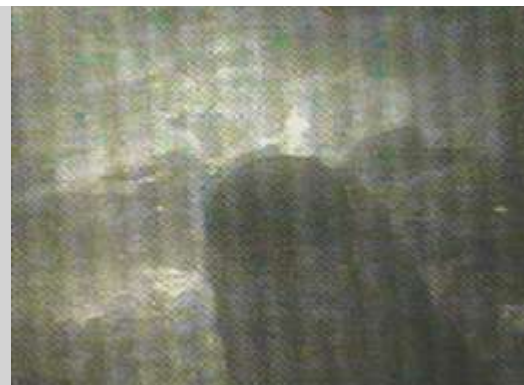
Drop In @ 8 O'Clock

Infiltration: **Evidence**

Drop Condition: **Open**
